Present status of the BigRIPS cryogenic plant

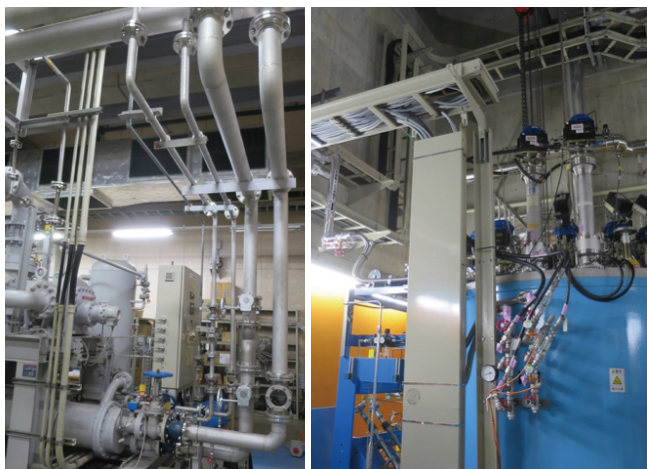
After the September 2017 incident wherein water pipelines for the refrigerator system were severely blocked by muddy impurities, we replaced the entire piping of the cooling water system for the BigRIPS cryogenic plant in March 2018. Figure 1 shows the new cooling water pipelines for the compressor unit and refrigerator. We changed the cooling water system for the refrigerator from the cool-water system using cooling towers to the chilled-water system using RIBF absorption chillers. The cooling efficiency of the turbine system has greatly improved.

Fig. 1. New cooling water piping for the compressor and refrigerator.

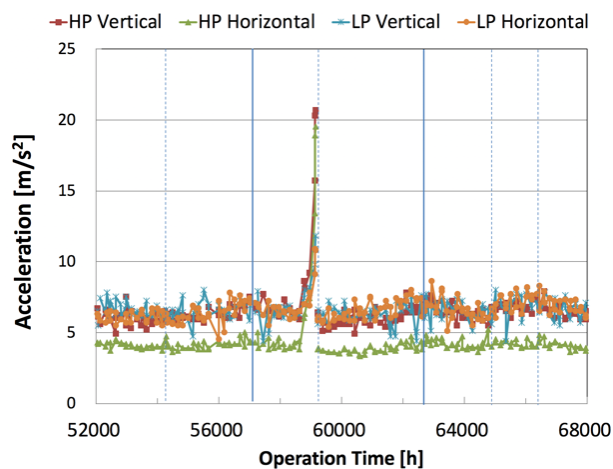
Figure 2 shows the vibration acceleration in the vertical and horizontal directions as a function of the total operation time. We measured the vibrations of the compressor at the high-pressure and low-pressure sides since 2015. Except the rapid increase of the vibration acceleration at the operation time of 59,000 h, which indicates the damage in the bearing unit that occurred in Dec. 2016,¹⁾ the vibration acceleration stayed less than 8 m/s^2 during the operation period.

Fig. 2. Vibration acceleration of the compressor unit.

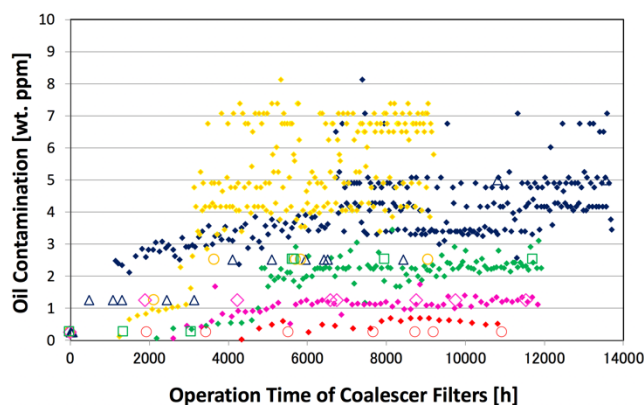
Figure 3 shows an estimate of the oil contamination level at the entrance of the third coalescer vessel as a function of the coalescer filter operation time. By mea-

Fig. 3. Oil contamination at the entrance of the third coalescer vessel.

suring the operation interval of the drain valves of the coalescer vessels in the compressor unit, the oil contamination level was evaluated.²⁾ The navy blue, green, and yellow diamonds represent the estimates for the 2008–2009, 2010–2011, and 2012–2013 operations, respectively. The estimate for the 2014–2015 and 2016–2018 operations are shown with pink and red diamonds, respectively. The oil contamination values measured using the oil check kit are also shown. The open triangles, squares, and circles represent the results for the 2008–2009, 2010–2011, and 2012–2013 operations. The results for the 2014–2015 and 2016–2018 operations are indicated by the open diamonds and circles, respectively. Both estimations of the oil contamination level are consistent with each other and the performance efficiency of the latest filter elements seems to be better than that of the others.
